# FINAL REPORT

Post Lay Inspection  
Of  
33 kV HVAC Cable  
At  
KENTISH FLATS WIND FARM

## **SURVEY MAINTENANCE NO. 2**

PROJECT : SURVEY OF HVAC POWER CABLES KENTISH FLATS OFFSHORE WIND FARM

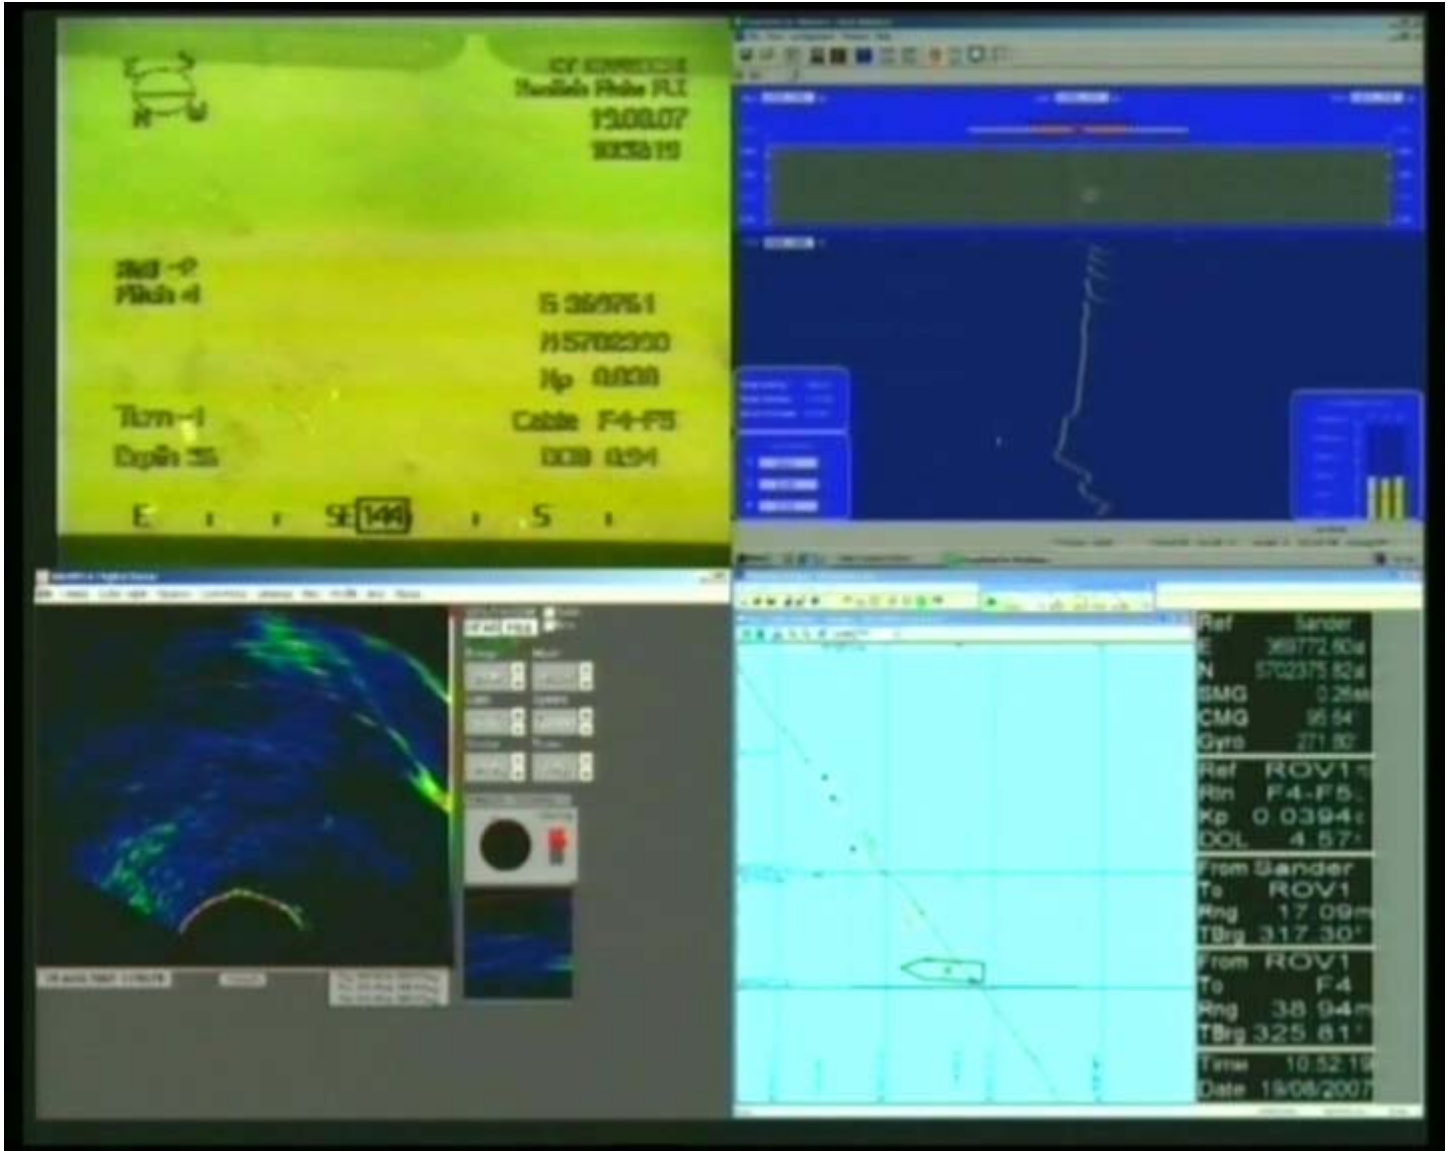
Example of Screen dump when ROV is 38 meters from WTG F4 driving towards F5.

- 1: Front camera of the vehicle – position – KP down the route – time and date – depth and heading
- 2: TSS 440 display burial depth tracing pos of the cable and tracking track of the cable
- 3: SONAR image in front of the vehicle.
- 4: Navman display, position of surface vessel, and sub sea vehicle.
