REVIEW OF CABLE INSTALLATION, PROTECTION, MITIGATION AND HABITAT RECOVERABILITY

The Crown Estate

EOR0744
Cable Installation, Protection,
Mitigation and Habitat
Recoverability
Rev03
12 November 2019

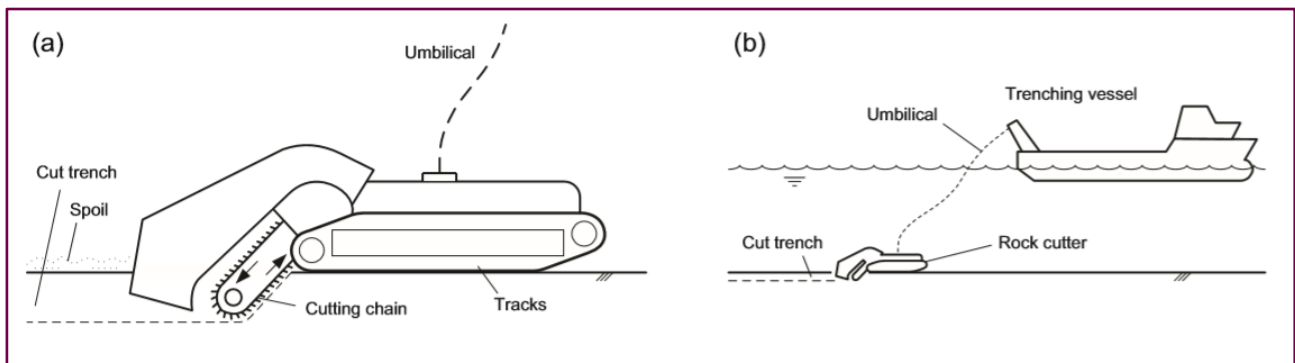
Figure 2.4: Chain cutter. (a) Principal components, (b) Pre-lay rock cutting operations (DNV, 2016).

2.4.3.1 Mechanical trenchers physically cut a trench, usually with a series of conical picks mounted on either a wheel or as a chain on a mechanical digging boom (Figure 2.4). The typical process is for the trencher to engage with and raise the cable whilst deploying the wheel or chain below and then for it to progress forward digging a trench.

2.4.3.2 Mechanical trenchers are best suited for hard ground conditions i.e. stiff clay. They do not perform well in granular soils as the silica causes high wear on the picks and the trench tends to collapse before the cable touches down, although there are trenchers on the market which include jetting systems and cable depressors which keep the trench open until the cable touches down.

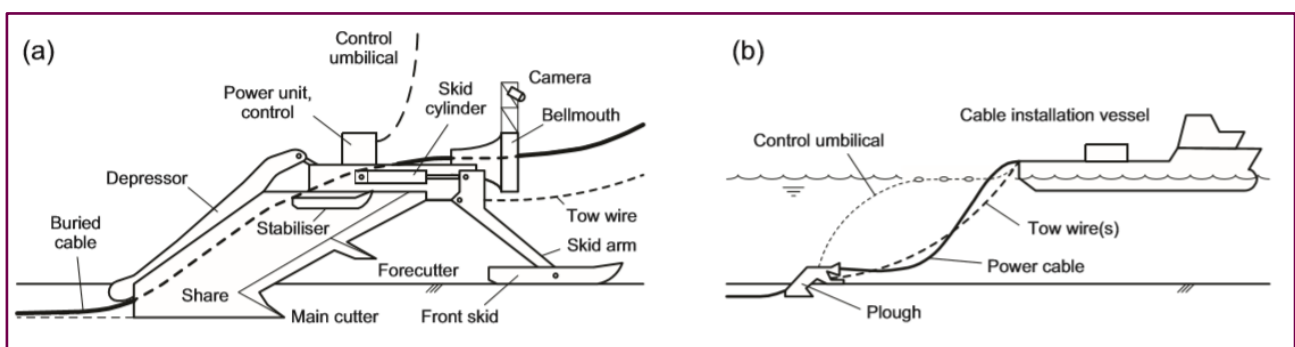
Figure 2.5: Subsea cable plough. (a) Principal components, (a) Cable lay operations (DNV, 2016).

2.4.4.1 Cable ploughs come in a variety of shapes and sizes and are designed specifically for different soil types and burial depths. All ploughs are towed from a vessel or barge which must be able to provide adequate tow force, or in the case of landfall approaches pulled in from a fixed anchor point. Some ploughs are designed to allow for simultaneous lay and burial as shown in Figure 2.5, where the cable is lowered and fed through the plough and into the trench. Other ploughs are used as a pre-lay activity to plough a large furrow for the cable to be lowered into.

2.4.4.2 Ploughs can be either non-displacement or displacement. Non-displacement ploughs trench and bury the cable in a single pass leaving less disturbance on the seabed and are typically used for simultaneous lay and burial. They are often fitted with additional features to improve performance in certain soils, for example water jets for burying in sand.

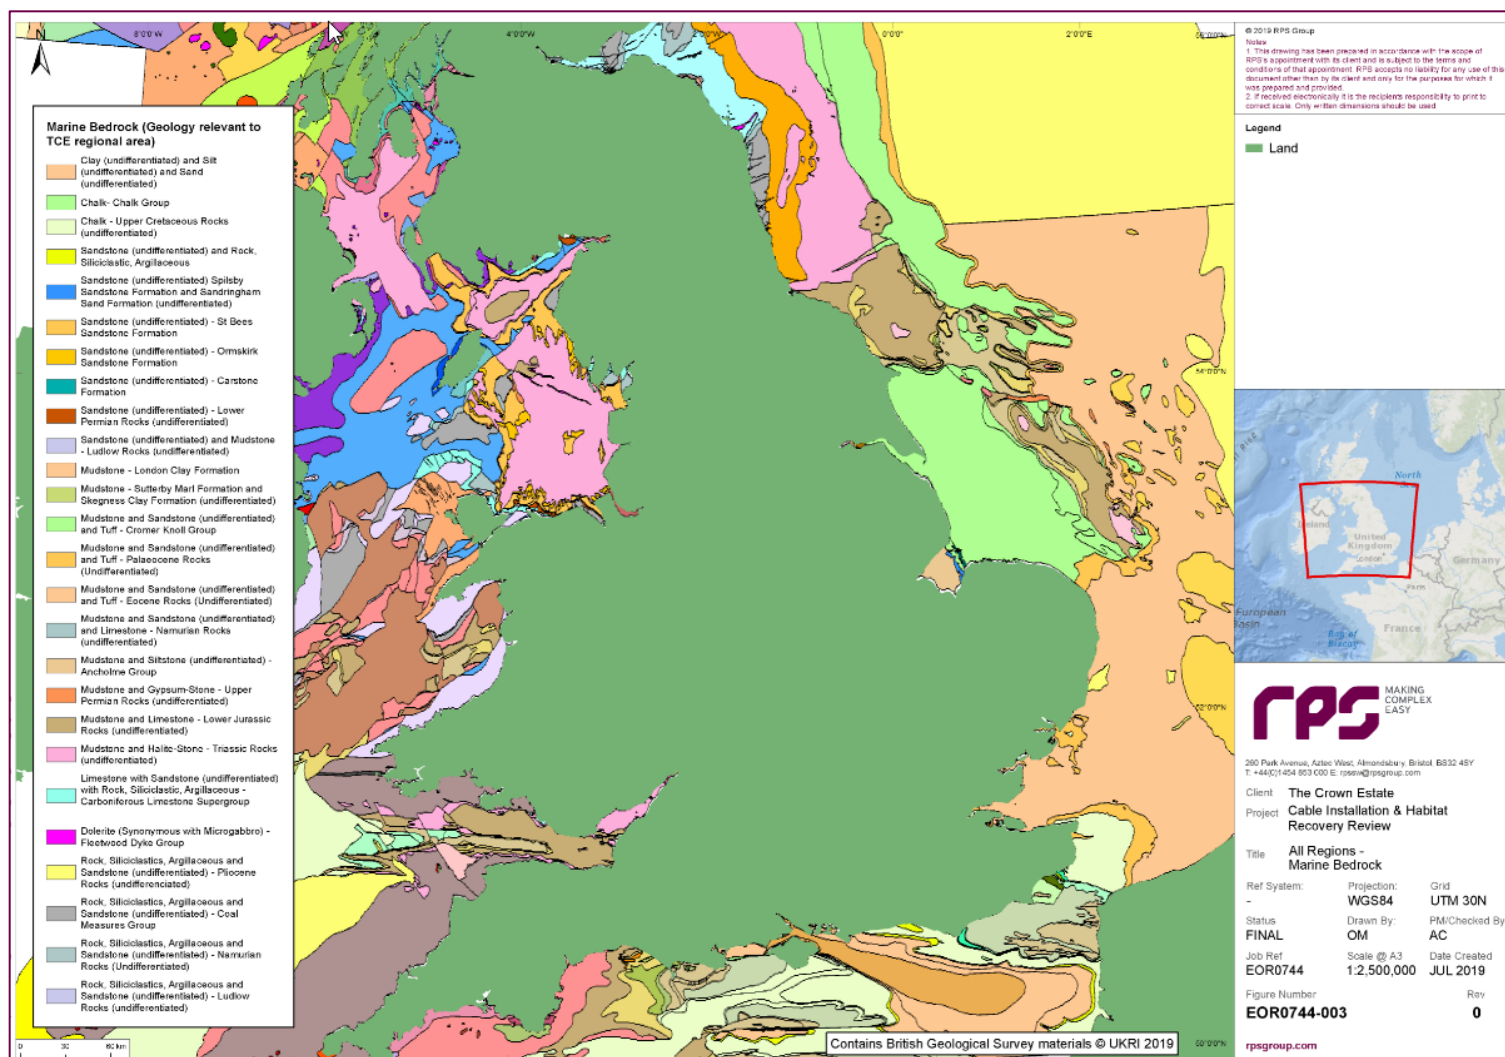
Figure 3.3: Marine Bedrock Around the UK.

- 3.3.2.3 To gain a clearer understanding of the bedrock and subsurface geology across the TCE Regions, publicly available data from the British Geological Survey (BGS; BGS Geology: marine bedrock 250k) were used to provide a broad description for each of the TCE Regions. Figure 3.3 provides an overview of this data for the UK, with the same data provided for each of the TCE Regions in the charts in Appendix B. This provides the basis of information on marine bedrock and is assumed to be correct where no additional data is provided for a particular project in that region. The principal bedrock delineations across the regions are summarised in Table 3.5.

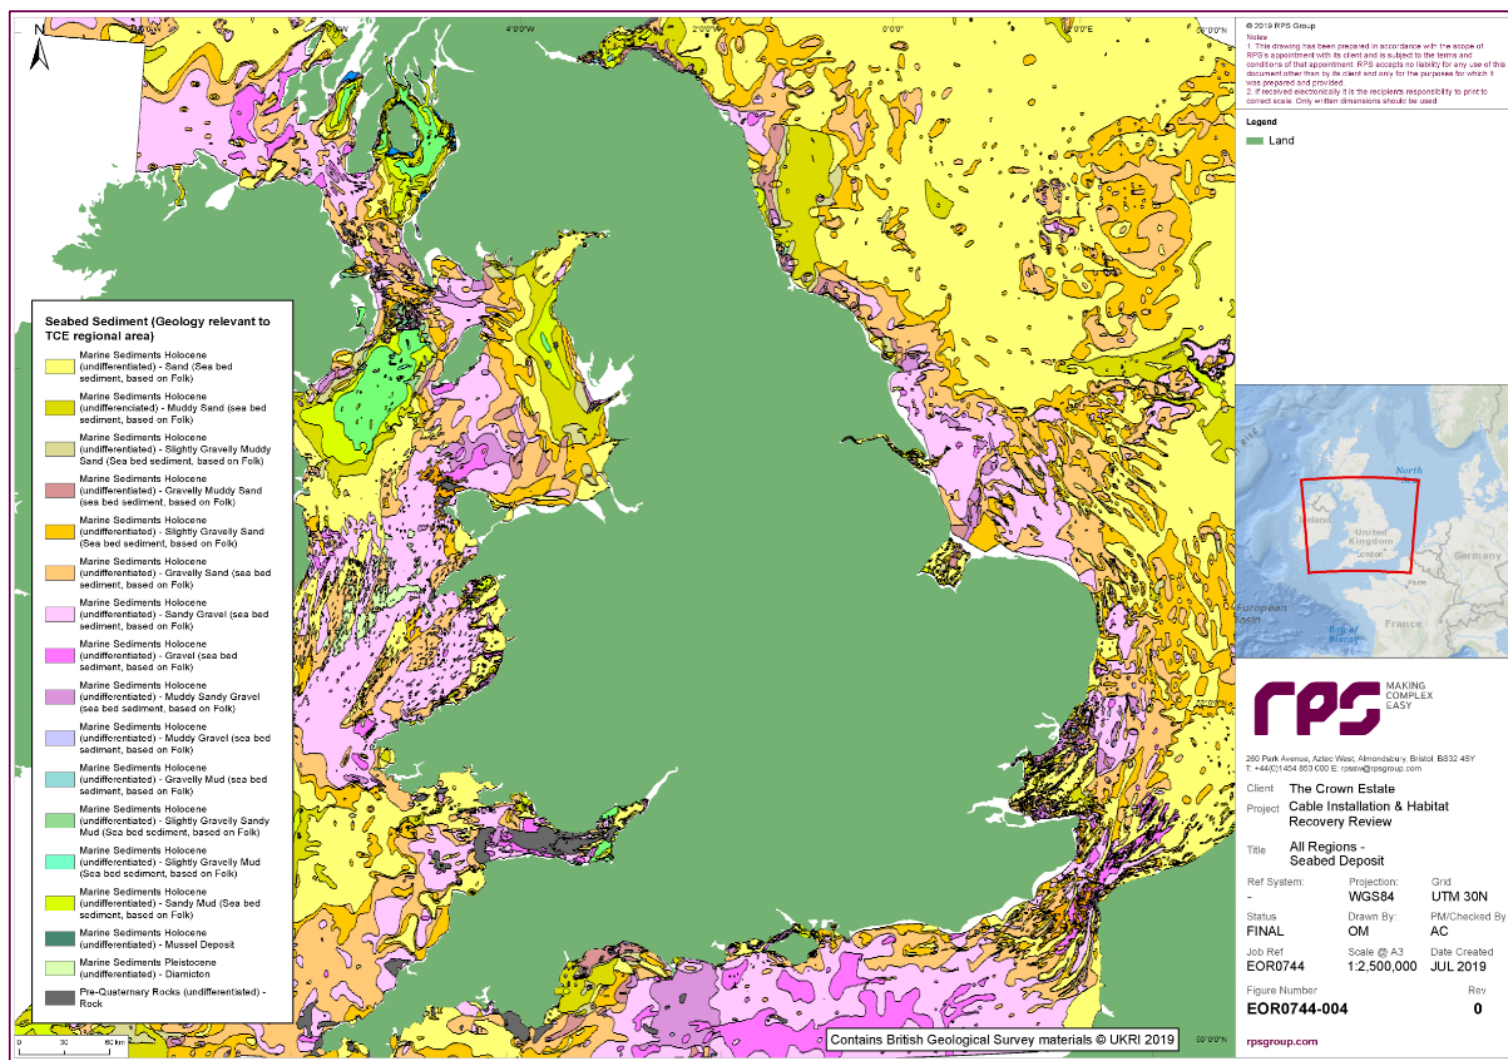
Figure 3.4: Marine Seabed Sediment around the UK.

- 3.3.2.7 The principal sediment delineations across the TCE Regions are presented in Table 3.6, however it should be noted that only the top surface layer of sediment is available within the dataset and should there be variations in the layers through the sediment, this information is not available, unless this has been provided at a project specific level. The seabed sediment identified as Rock and Sediment is likely highlighting that there may only be a thin veneer of sediment, and that bedrock is located close to the seabed surface.

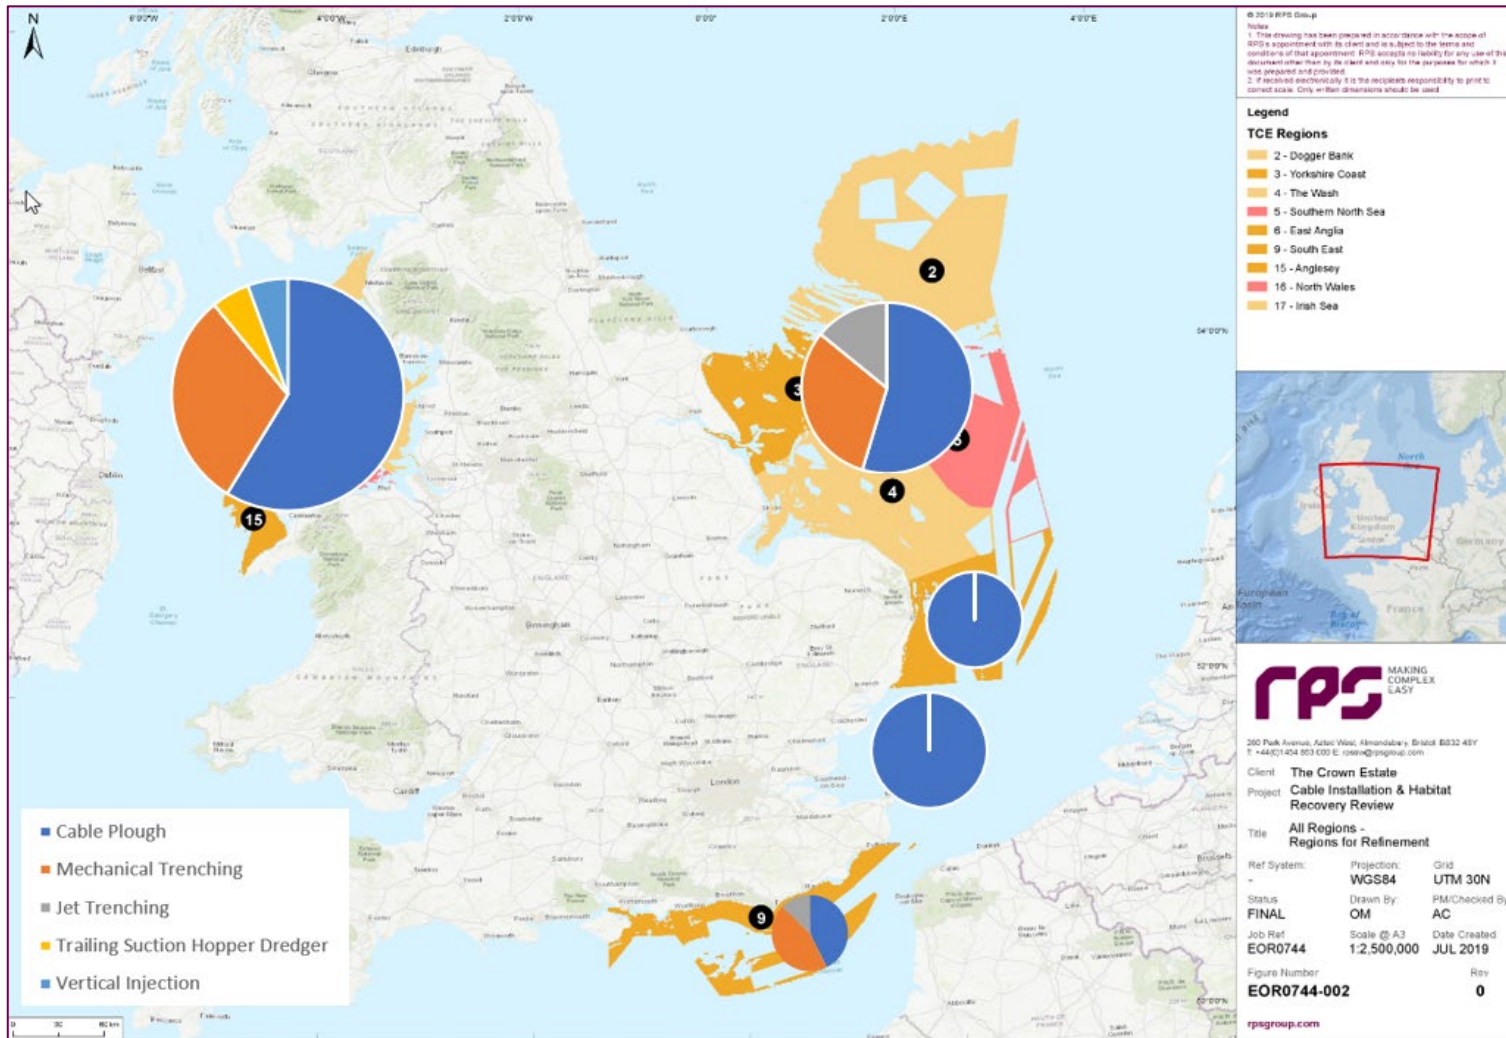
Figure 3.6: Summary Total Installation Lengths per Tool for each case study.

ground conditions, it is foreseeable that the right selection of tool from each group supports successful cable installation in the appropriate conditions.

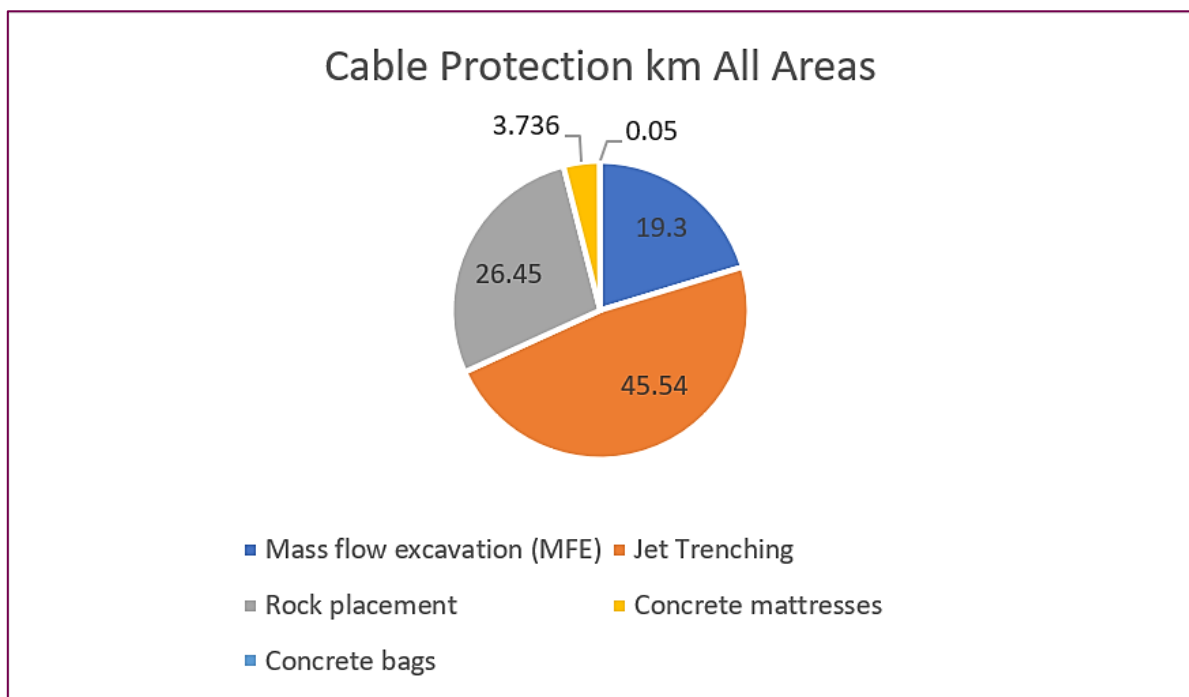
Figure 3.7: Total Protection Lengths per Method for all Case Studies.

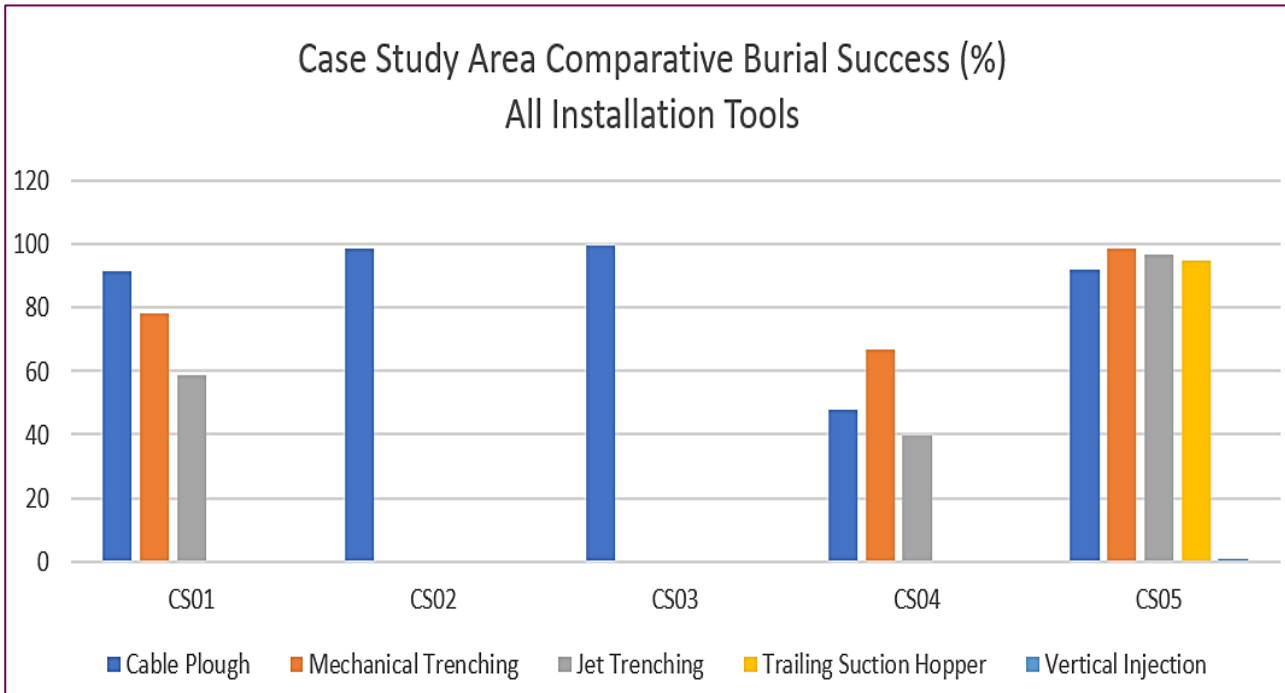
Figure 3.9: Comparative Burial Success for all Installation Tools.

3.3.5.1 Figure 3.9 below shows the percentage success for each installation tool type used in each of the case study areas. The installation tools/methods were used to different degrees across the five Case Studies, though three installation methods (i.e. plough, mechanical trenching and jet trenching) were used most commonly across the Case Studies, allowing for some comparison of the tools across regions.

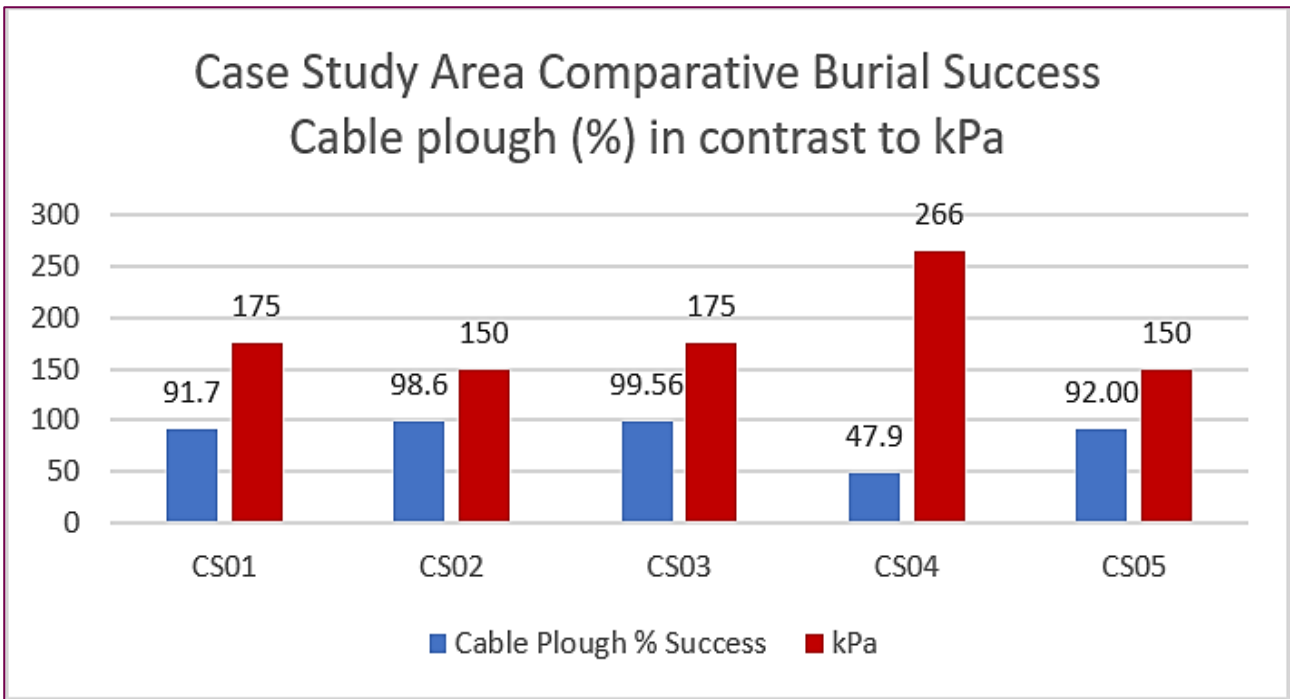
Figure 3.10: Comparative success of cable ploughs (%) relative to maximum shear strength values (kPa) for each Case Study area.

- 3.3.5.6 A secondary finding is in relation to the scale of impact on burial success between different installation tool types. Where the assumed same changes in substrate shear strength between different Case Studies is seen, there are different levels of success between the tools. The jet trencher and the cable plough are more affected by the increase in substrate shear strength and burial success reduces by over 50% across the Case Studies. In comparison, the mechanical trenching equipment cable burial success is reduced by a smaller degree, with greater burial success in harder soil types (e.g. CS04; see Figure 3.11). This finding is again in line with the DNV (2016) guidance (see Figure 2.2).

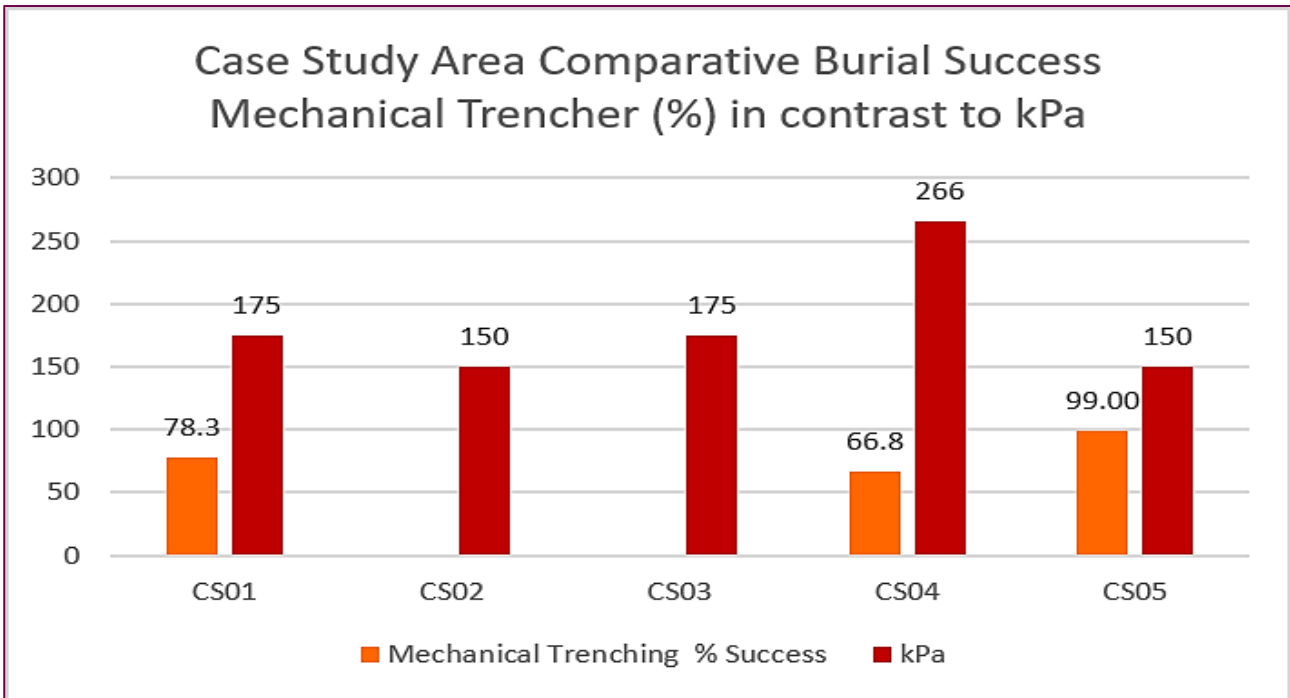
Figure 3.11: Comparative success of mechanical trencher (%) relative to maximum shear strength values (kPa) for each Case Study area.

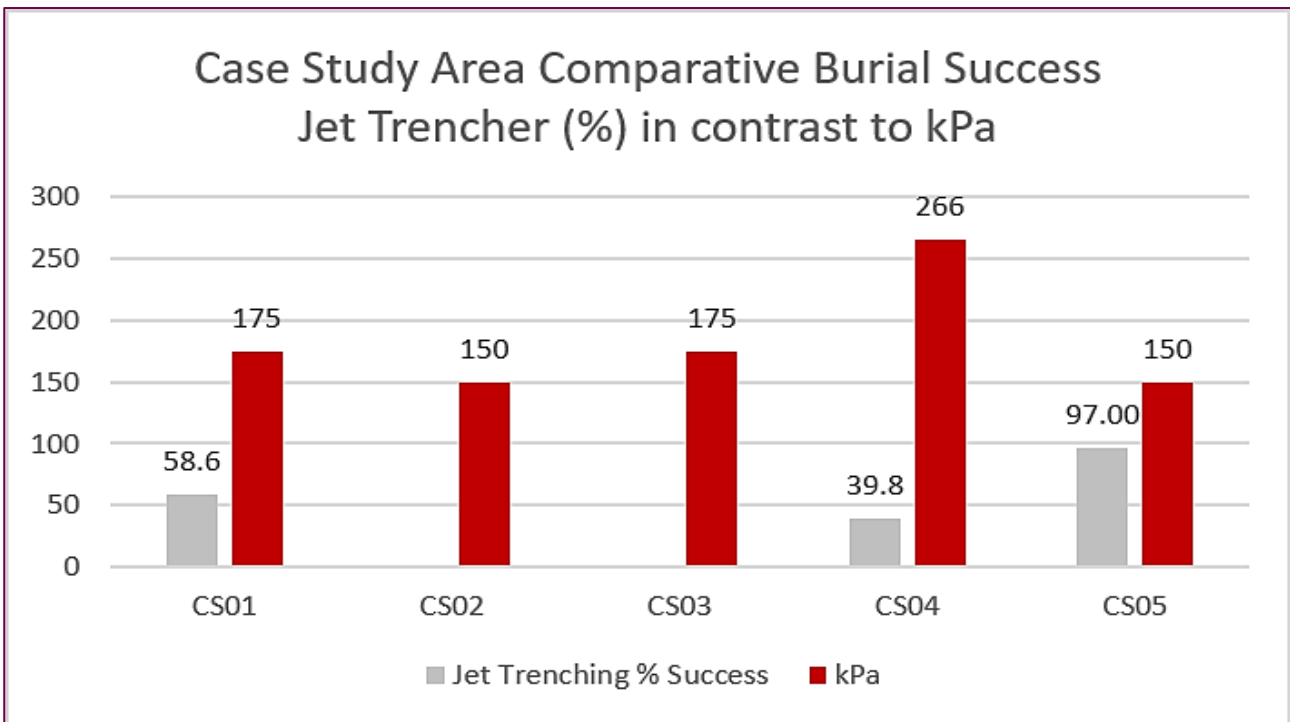
Figure 3.12: Comparative success of jet trenching relative to maximum shear strength values (kPa) for each Case Study area.
