GUNFLEET SANDS 3 DEMONSTRATION PROJECT

POST-CONSTRUCTION YEAR 1 – MARINE LICENCE
ENVIRONMENTAL MONITORING REPORT

DONG ENERGY GUNFLEET SANDS DEMO (UK) LIMITED

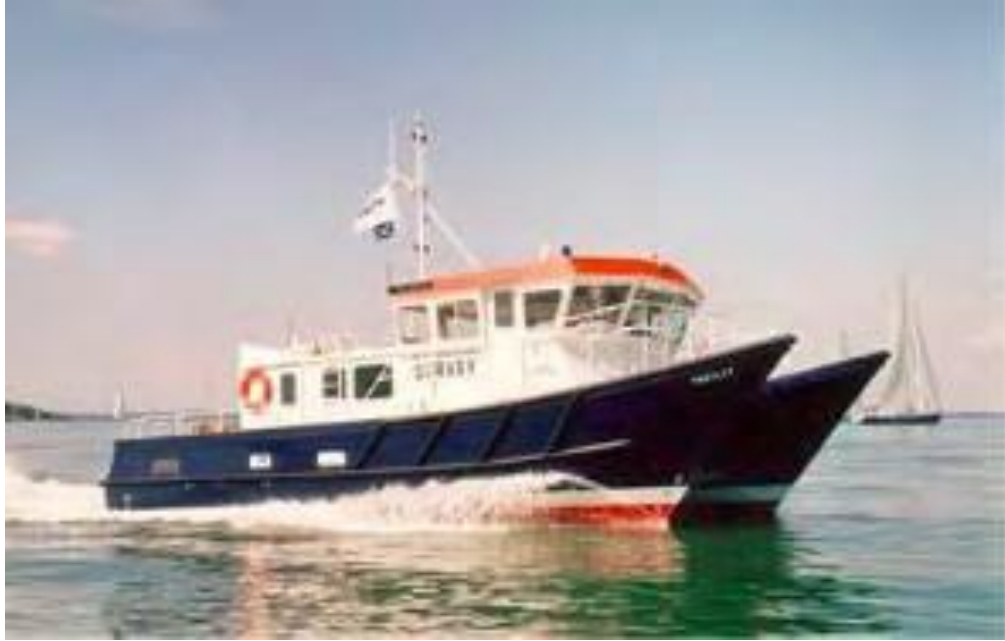
Figure 3 - PLA survey vessel ‘Yantlet’ (PLA, 2014).

4.2.4. All first year post-construction surveys were carried out using the Port of London’s survey vessel ‘Yantlet’ (Figure 3), with bathymetric data collected using a hull-mounted Reson SeaBat 8125h MBES. The location of the survey areas is shown in Figure 2.

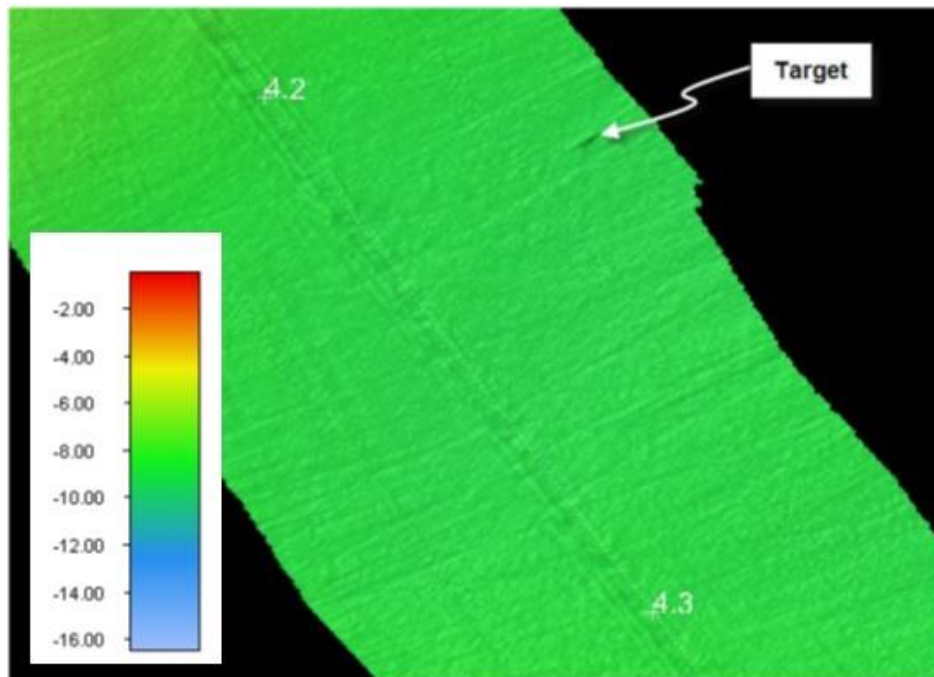
- 4.2.7. A new target has been identified at kilometre point (kp) 4.235 (Figure 5), 40m east of the cable route. The target is located at 372596.3E, 5734334.8N, length 5m width 0.75m and a height of 0.3m above the surrounding bed. The least depth on the target is 8.4m. The target does not have consequence to cable integrity and therefore, no further action is proposed.

Figure 5 - Target (kp4.2 - kp4.3) (PLA, 2014).

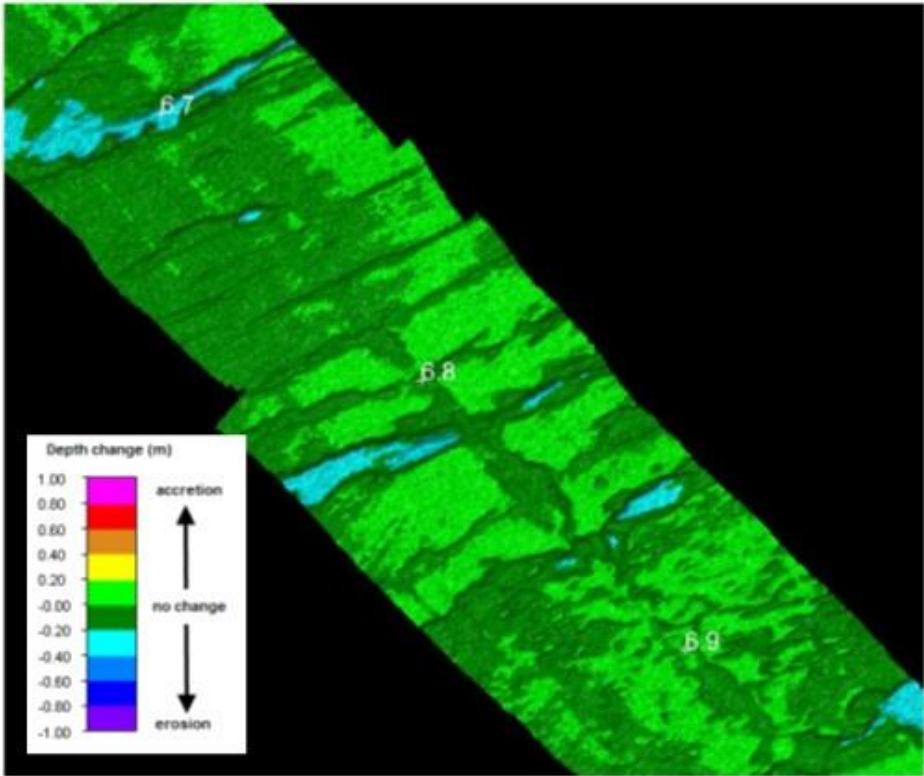
Figure 6 - Difference model comparing April 2014 with October 2013 data between kp6.7 and kp6.9 (PLA, 2014).

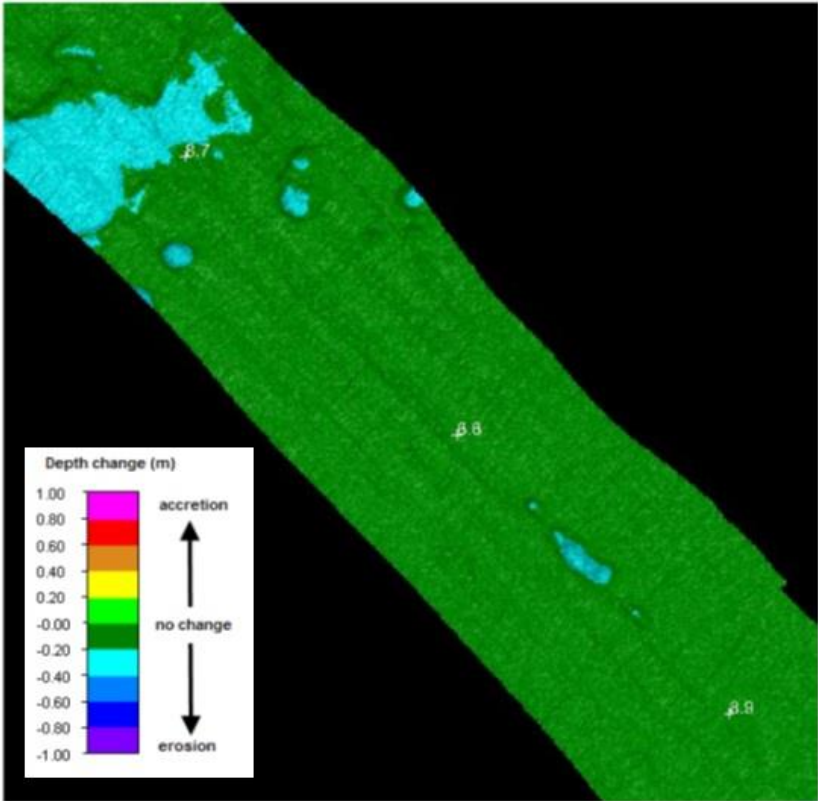
4.2.8. Table 8 provides descriptions of the bedforms present along the export cable route from the April 2014 surveys. There has been little notable change from kp0.8 to kp6.55 between October 2013 and April 2014. On the north of the bank, there has been some erosion on the slope between kp6.55 and kp7.2 (as described in Table 8), with some of the erosion shown in Figure 6 (kp6.7 – 6.9). The difference model shows the slope continuing to be cut away. In this area, the trench along the charted kp has deepened by approx. 0.1m compared to the surrounding bed. Between kp 8.3-kp 8.9 there has been up to 0.3m of erosion. At kp8.85, the erosion is concentrated over the charted cable route (Figure 7).

Figure 7 - Difference model comparing April 2014 with October 2013 data between kp8.7 and kp8.9 (PLA, 2014).

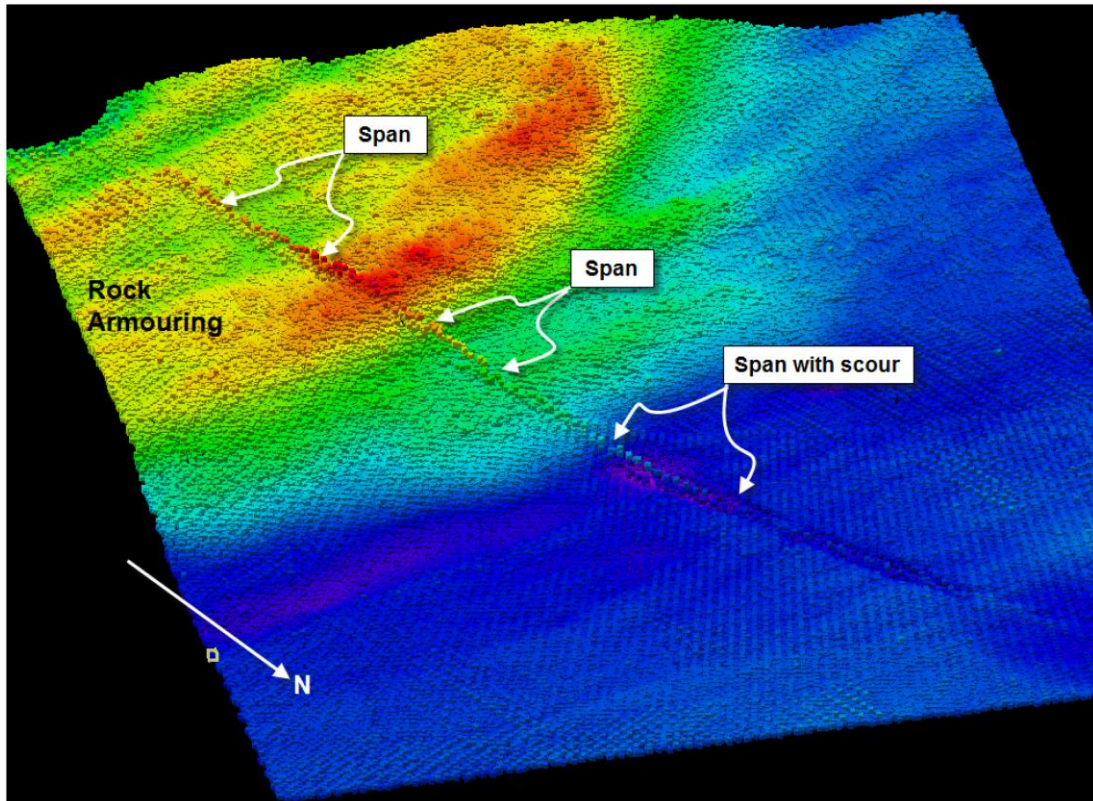
4.2.9. Figure 8 shows the export cable running north out of WTG F00. The cable appears to span across the ridges of the rock armouring and as the cable descends off the rock armouring. This is also seen at the southern side of F00 and at G00. There also appears to be a span where the bed has scoured around the cable, close alongside the rock armour. The extents of the cable exposures and spans (as they enter the monopile) are detailed in Table 9. There are similar scour features under the cables close alongside the rock armouring at the southern side of F00 and at G00. These smaller spans have not been detailed in in Table 9.

Figure 8 – Export cable span at WTG F00 (PLA, 2014).

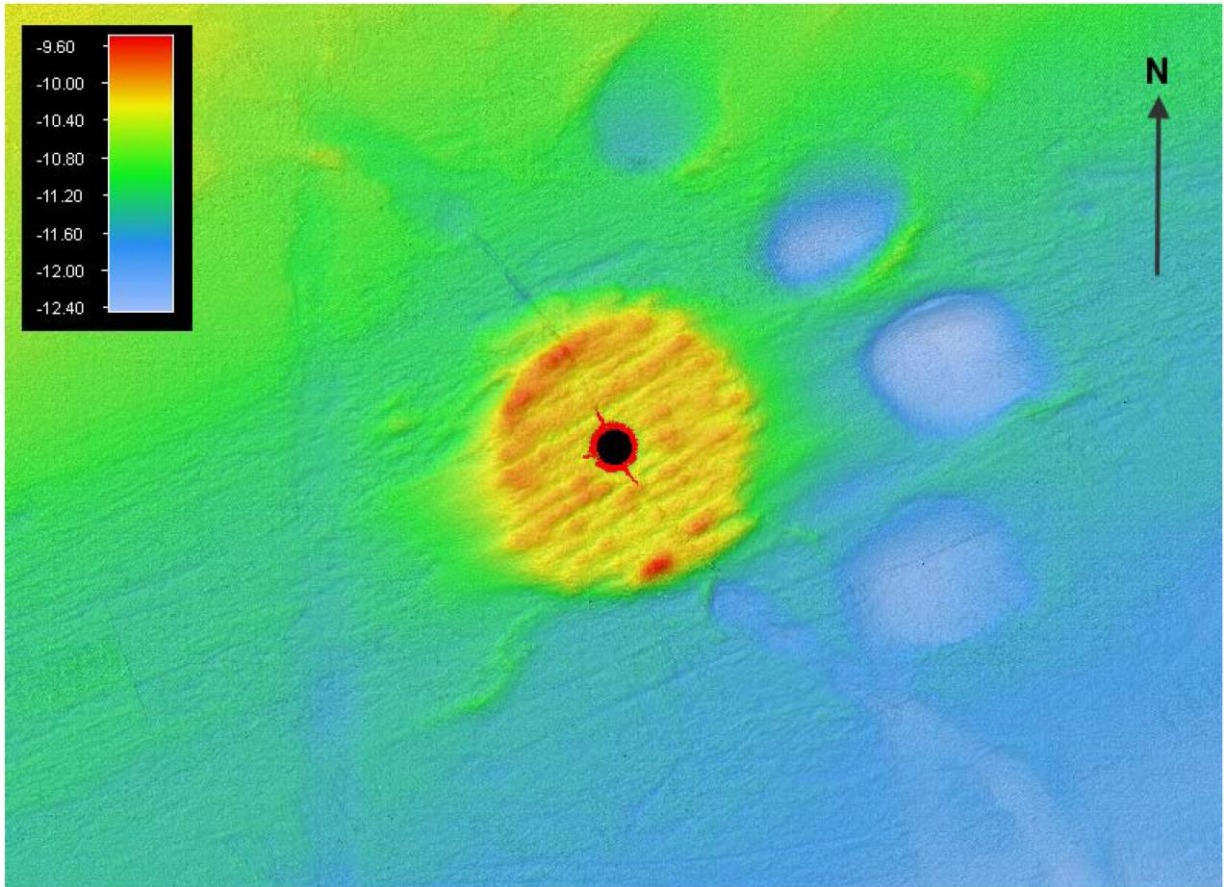
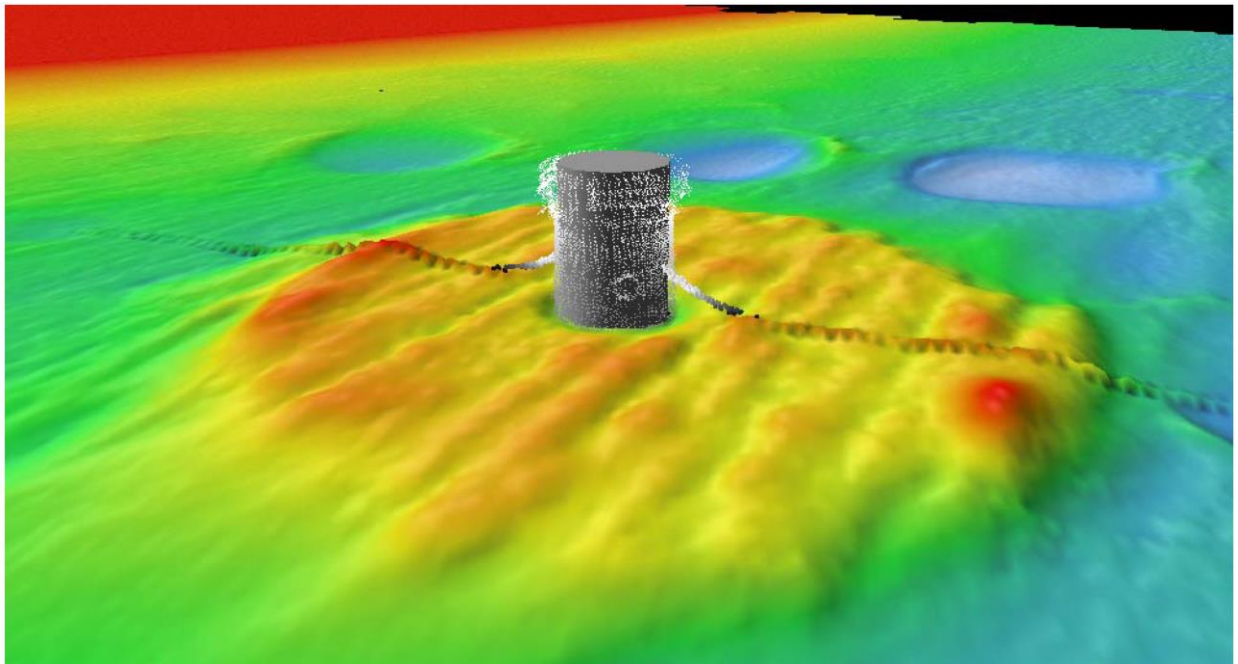
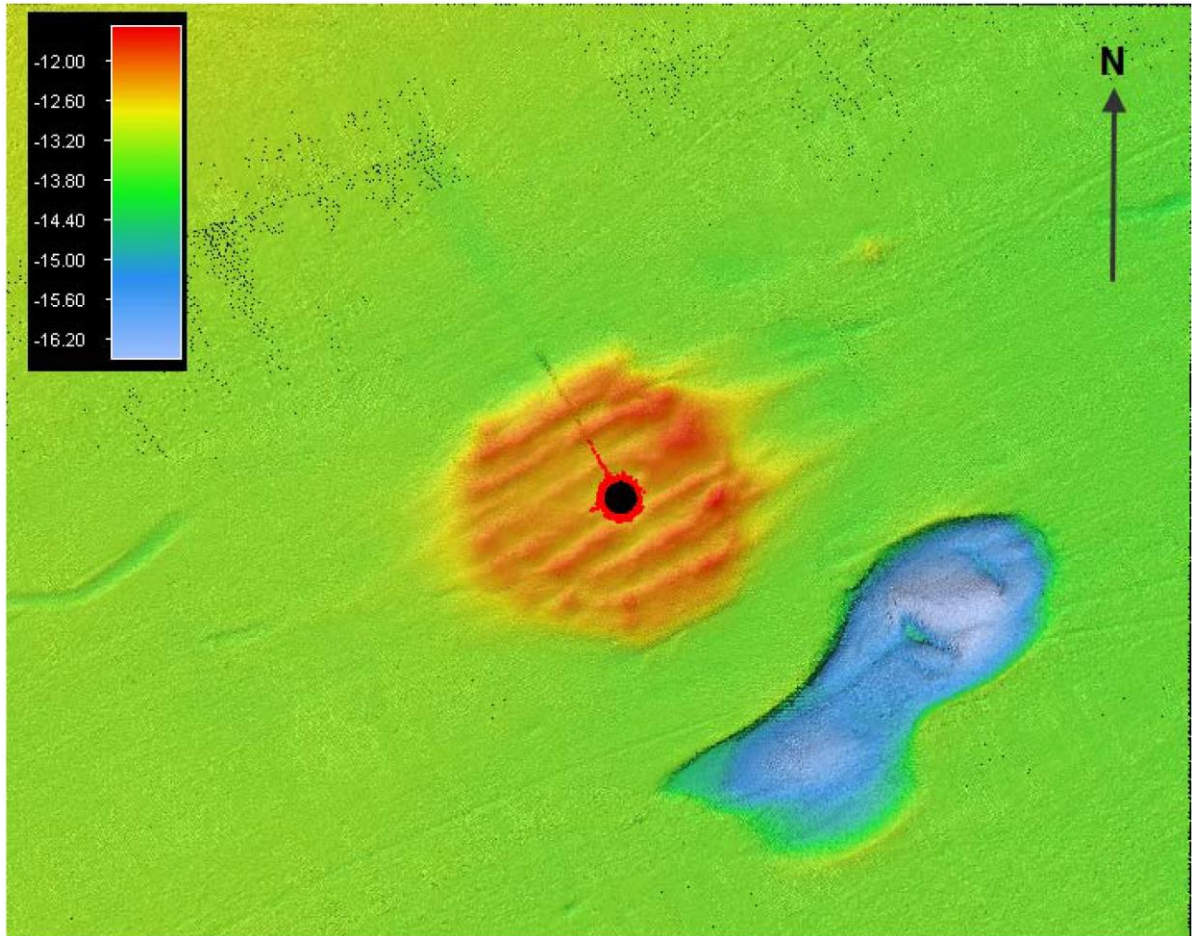
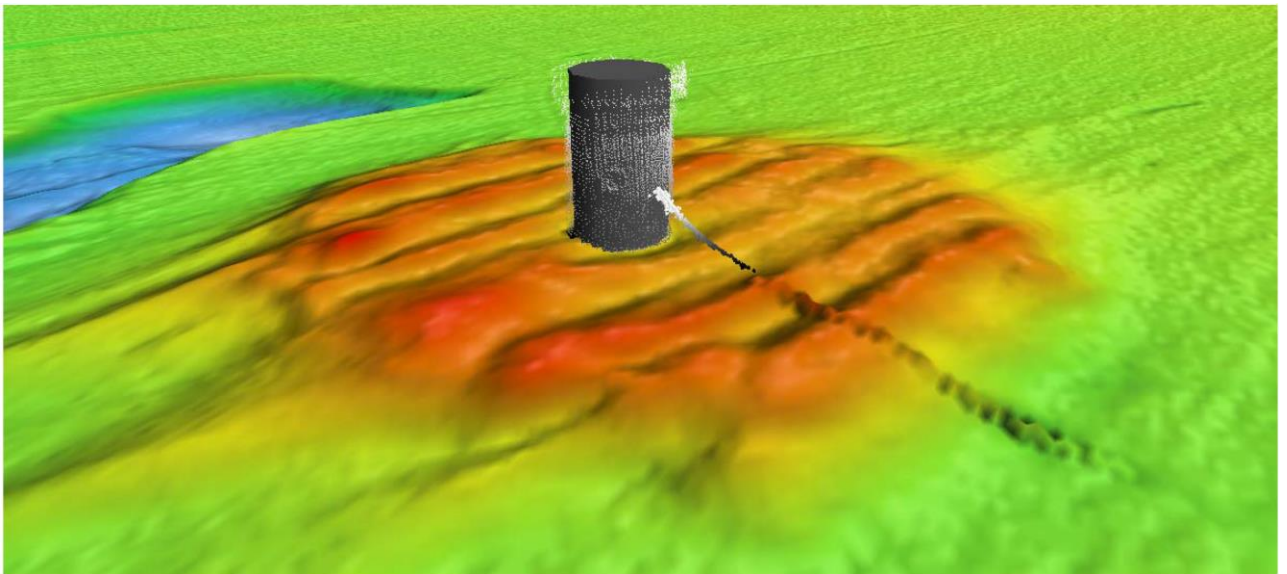
- 4.2.10. The exposed export cable and inter-array cable can be seen in Figure 9 to Figure 13. The extent of the exposed cables was to a maximum of 54m to the south of F00. There has been no change in the extent of the exposed cable since the previous survey in October 2013.
- 4.2.11. The occurrence of the cable span in the vicinity of the foundation is due to the need for the cables to surface close to the scour protection to enter onto the scour protection. As this cable span is intentional and occurred during the installation process, no remedial action is proposed.

Figure 9 – Digital Terrain Model – WTG F00 (PLA, 2014).

Figure 10 – Point Cloud – WTG F00 (PLA, 2014).

Figure 11 - Digital Terrain Model – WTG G00 (PLA, 2014).

Figure 12 - Point Cloud – WTG G00 (PLA, 2014).

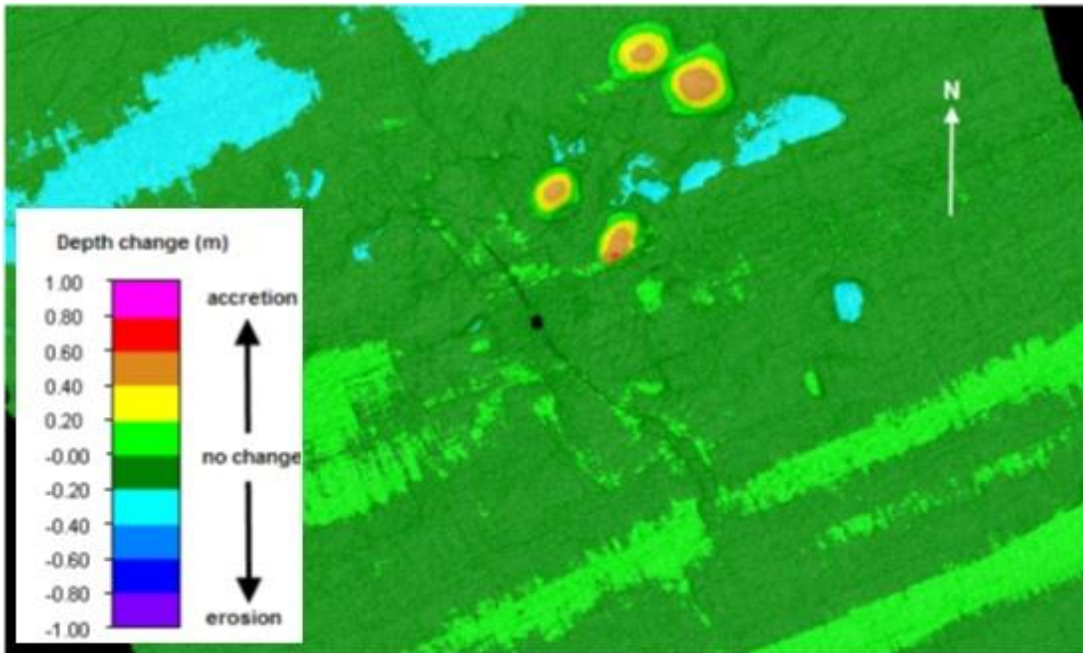
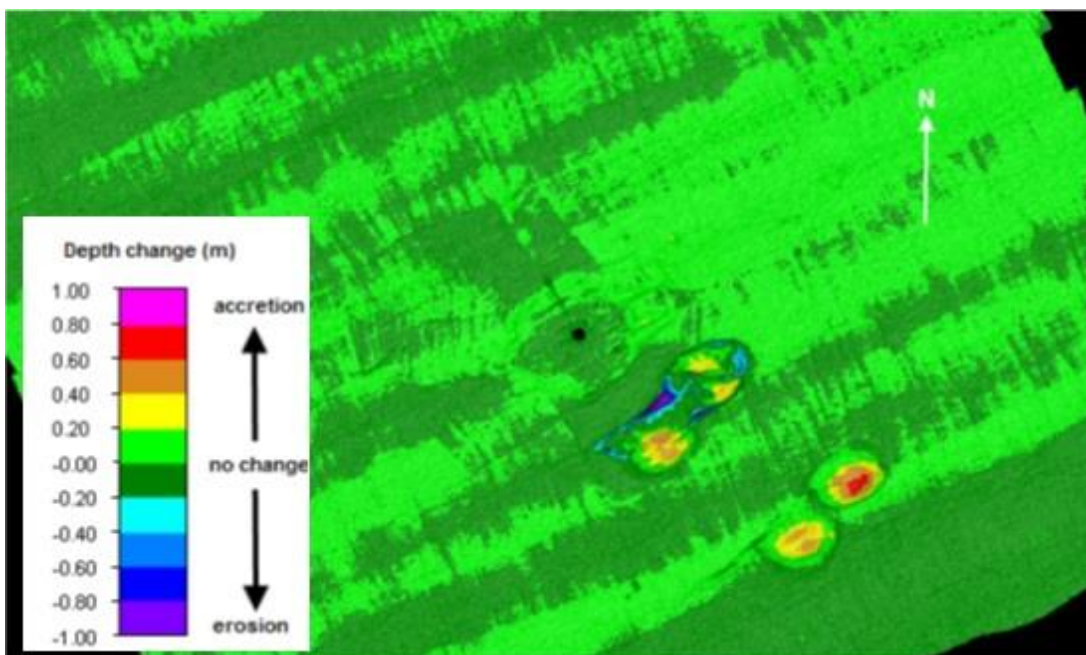
- 4.2.12. From the difference model and the difference surface charts which both compare the data from April 2014 with data from October 2013 (Figure 13 - Figure 14), it can be seen that jack-up footprints seen in the previous data have continued to infill (seen as accretion).
- 4.2.13. The difference model also shows there has been up to 0.3m deepening 100-150m north of WTG F00 (Figure 13). There does not appear to be any change in depth over the rock armouring or around the exposed cables. Figure 14 shows no significant change in the vicinity of WTG G00.

Figure 13 – WTG F00, Difference Model (April 2014 – October 2013) (PLA, 2014)

Figure 14 - WTG G00, Difference Model (April 2014 – October 2013) (PLA, 2014)

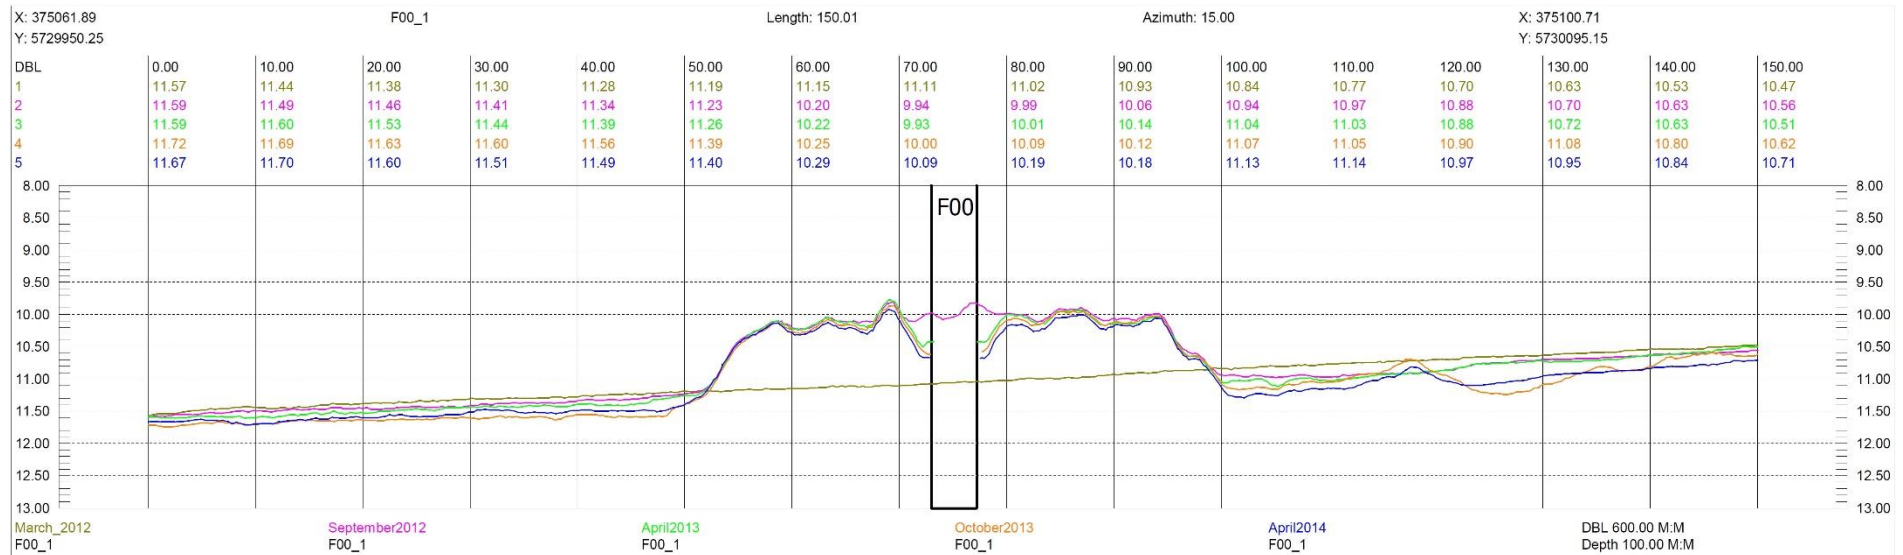
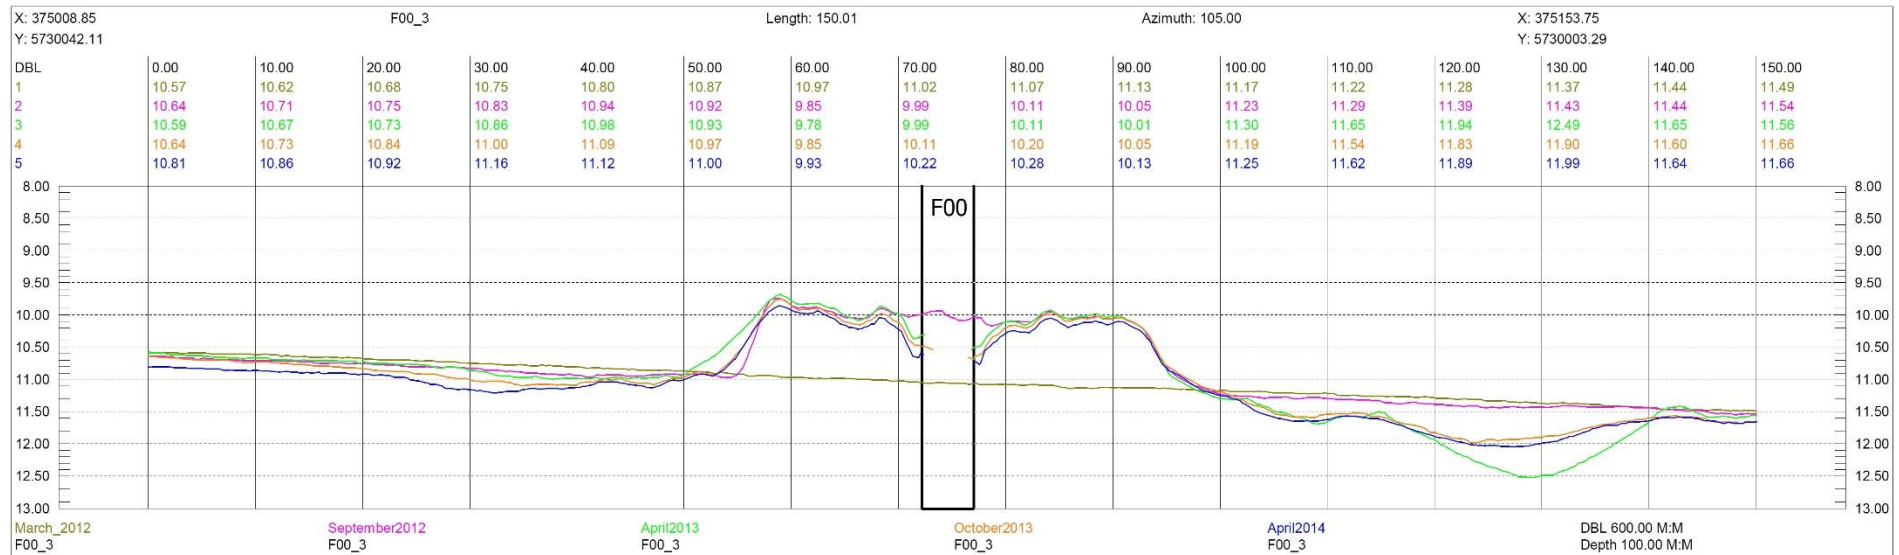
- 4.2.14. The cross-sections in Figure 16, Figure 17, Figure 19, and Figure 20 show profiles of the bed depth in the vicinity of the base of turbines F00 and G00. The cross-sections are cut at 45° intervals including along the expected scour direction. The cross section locations are shown in Figure 15 and Figure 18 below. It can be seen that there has been some erosion of the seabed over the wider area surrounding the scour protection (predominantly in the ENE-WSW direction). Since installation, there has been some build-up of material immediately adjacent to the scour protection.

- 4.2.15. The rock armour around the WTG F00 remains stable. Cross-section F00_1 (Figure 16) shows some accretion in the footprint left by the jack-up rig. Cross-section F00_3 (Figure 17) shows up to 0.2m erosion to the northwest of the scour protection. These depressions occurred during construction, as shown by the green line which represents the first survey since construction, and the depressions have shown accretion since that time.

Figure 16 - Cross section at turbine F00: Position 1 (PLA, 2014).

Figure 17 - Cross section at turbine F00: Position 3 (PLA, 2014).

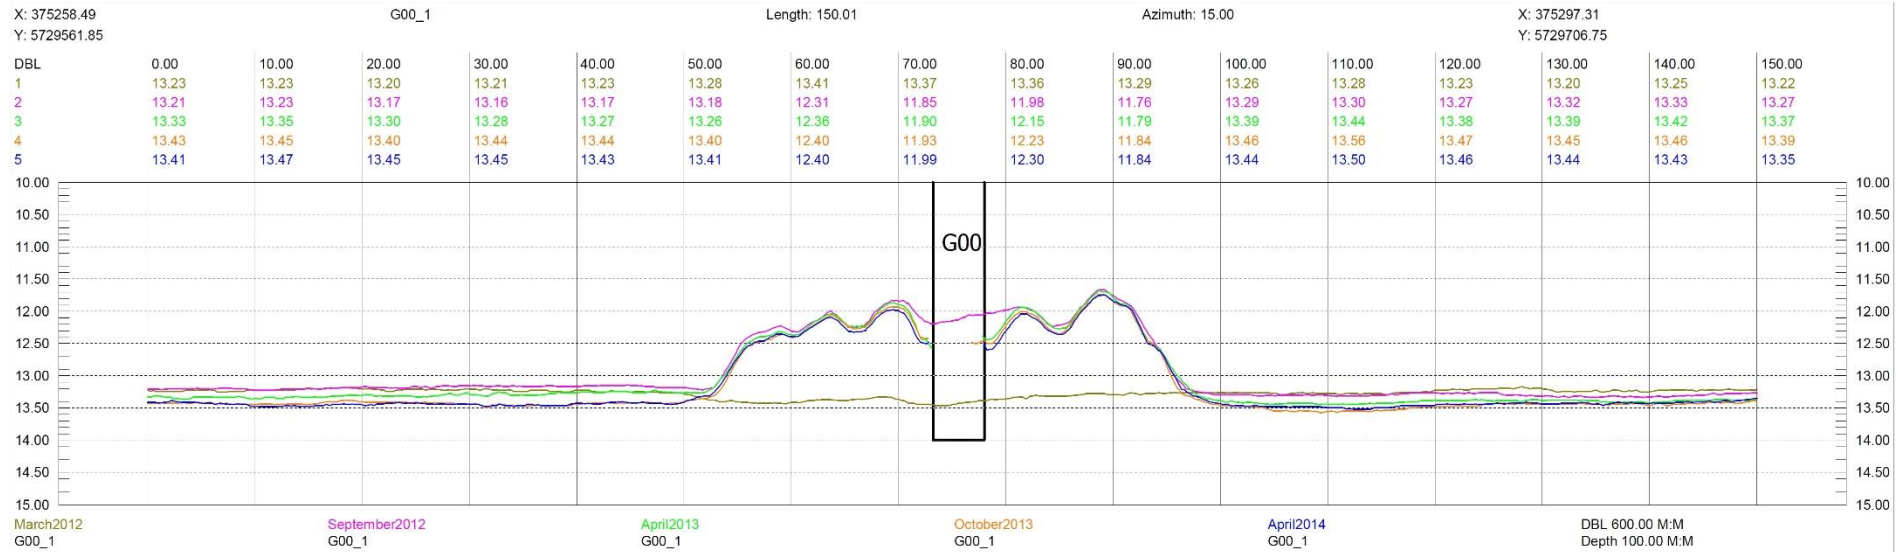
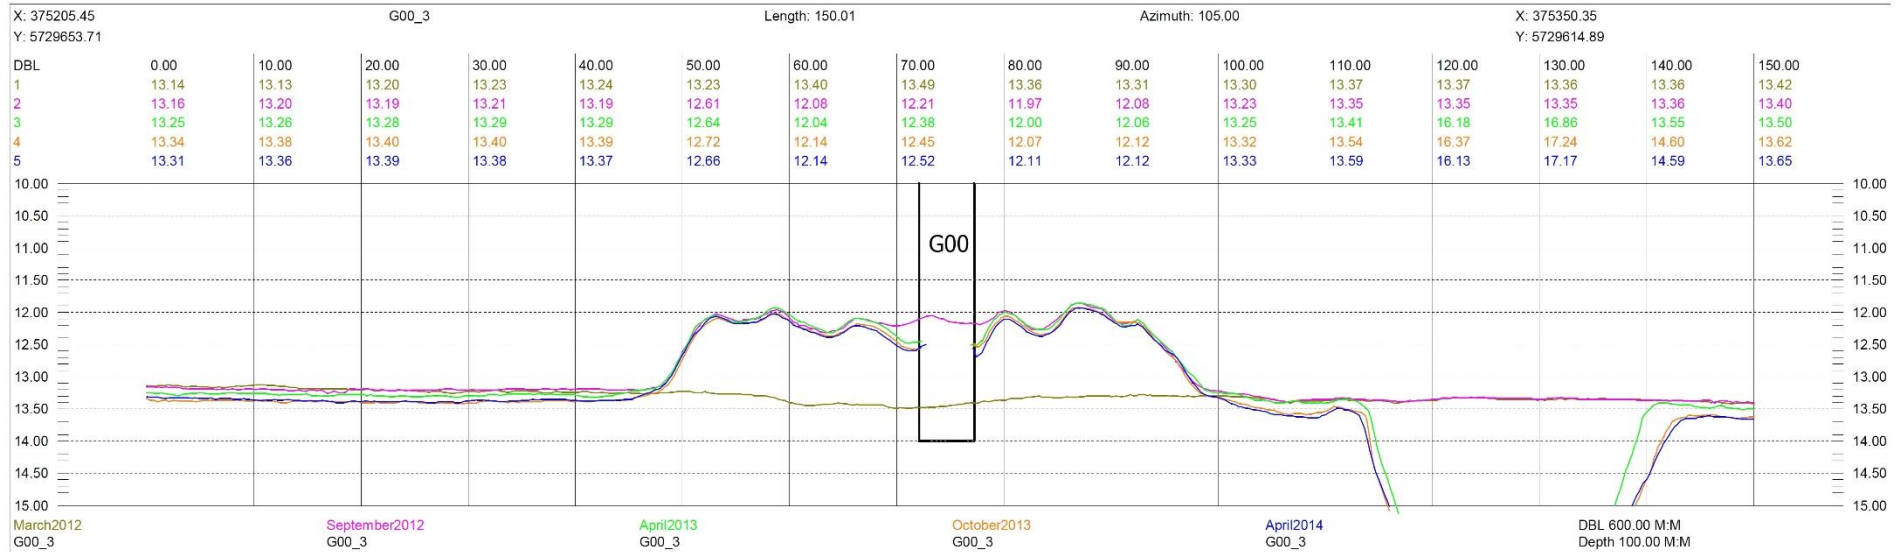
- 4.2.16. The cross-sections (Figure 19 and Figure 20) show that the rock armour is stable and there has been no significant change on the surrounding seabed since the previous survey October 2013.

Figure 19 - Cross section at turbine G00: Position 1 (PLA, 2014).

Figure 20 - Cross section at turbine G00: Position 3 (PLA, 2014).

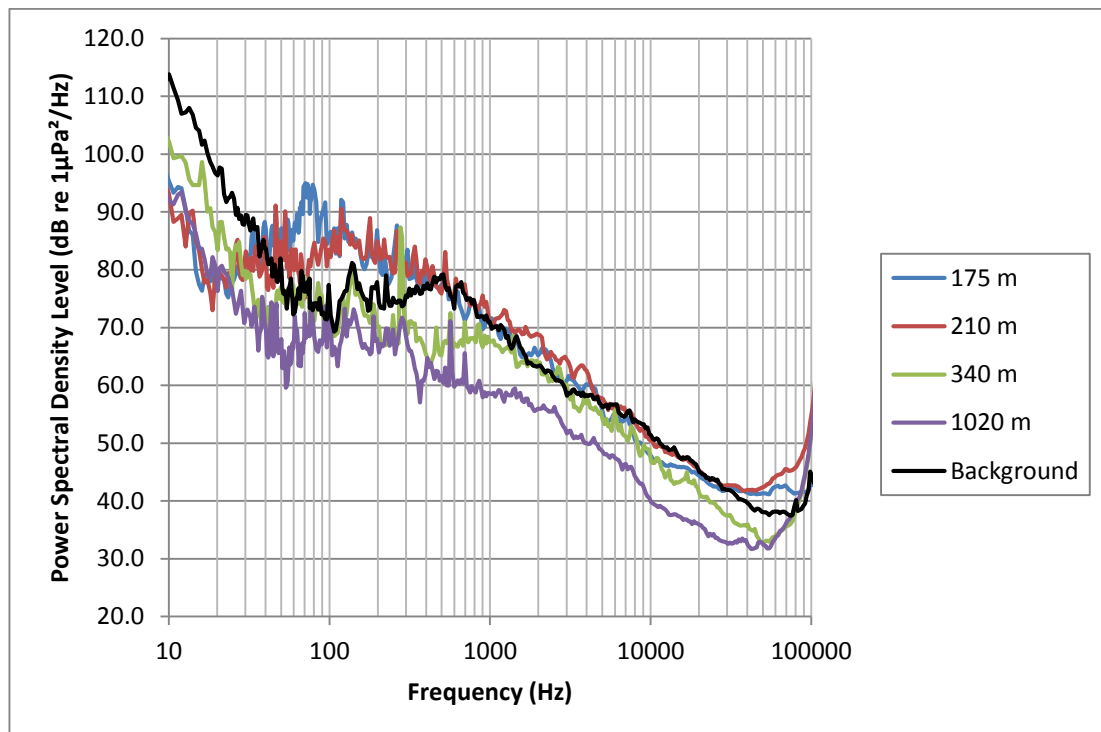
- 4.4.12. Measurements of underwater noise were taken at various distances from the two turbines at GFS3 in order to determine the extent of the sound propagation from the operational turbines. Figure 31 presents a power spectral density (PSD) plot of several measurements each at a different range from the turbines as well as a background measurement from March 2013. The PSD taken from the background measurements show that on 29th July 2014 measurements only exceeded the previously measured background levels across the frequencies at a range of less than 300 m from the operational turbines.

Figure 31 - PSD level plots of measurements taken at increasing distances from the wind turbines on 29th July 2014 (Subacoustech, 2014)

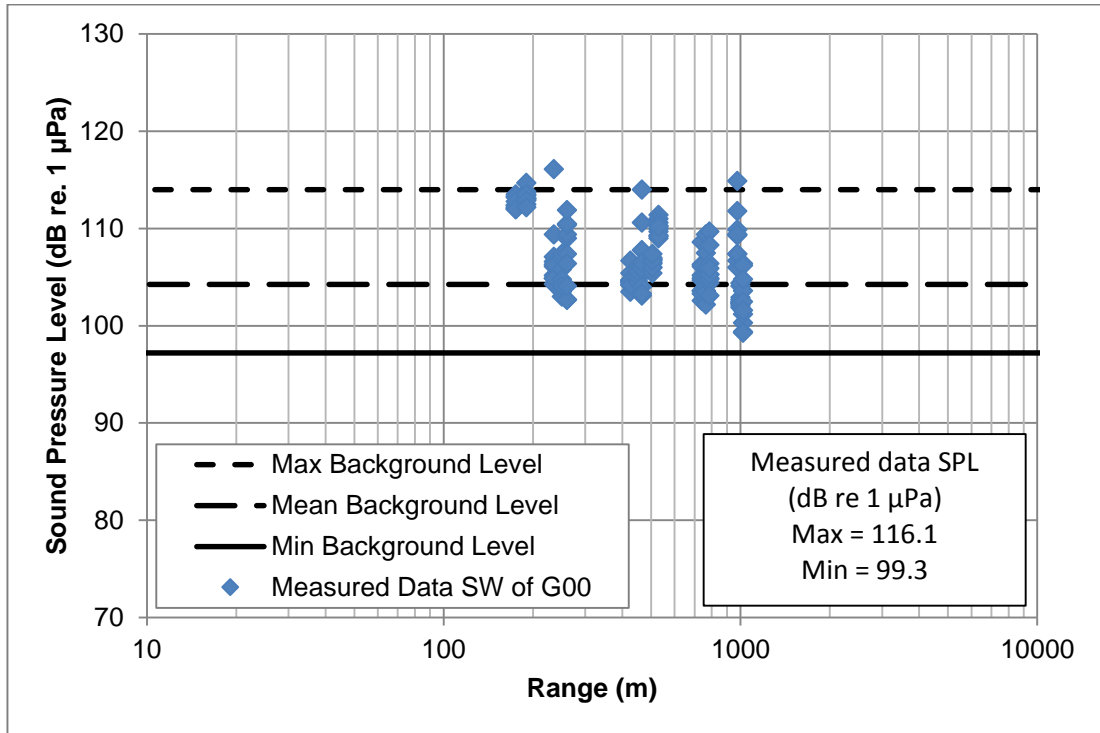
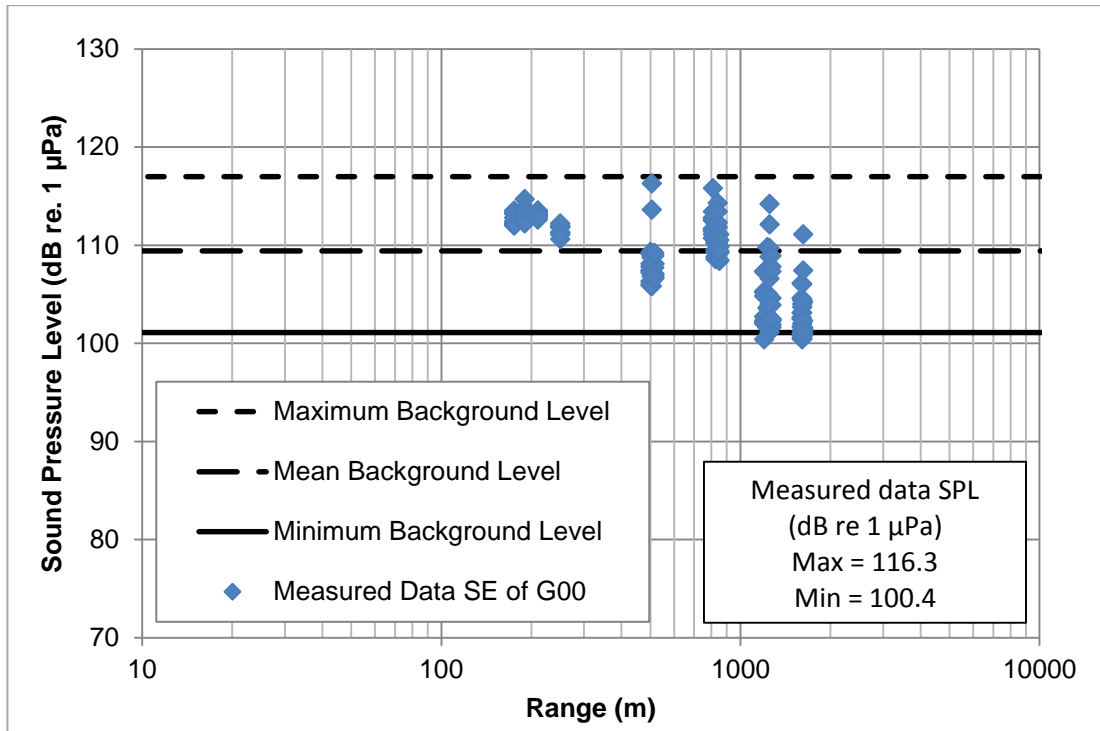
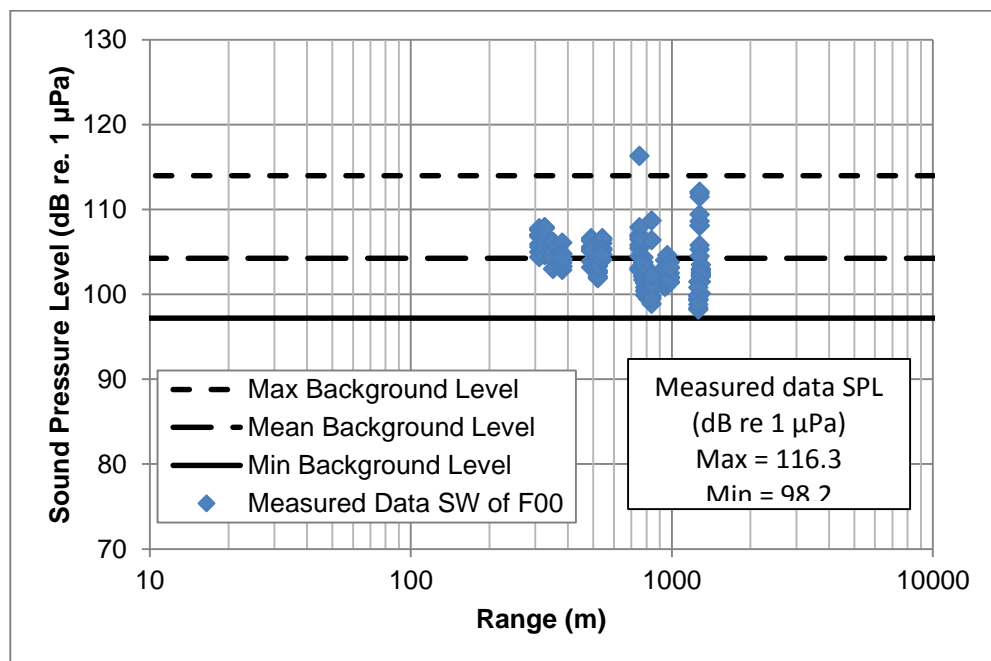
4.4.15. Figure 32 to Figure 34 all show the measured data to have a spread which ranges between the maximum and minimum background levels without showing any clear drop in level with range.

Figure 32 - Level versus range plot of data measured along the South West transect from G00 turbine on 29th July 2014 (Subacoustech, 2014)

Figure 33 - Level versus range plot of data measured along the South East transect from G00 turbine on 29th July 2014 (Subacoustech, 2014)

Figure 34 - Level versus range plot of data measured along the South West transect from F00 turbine on 30th July 2014 (Subacoustech, 2014)

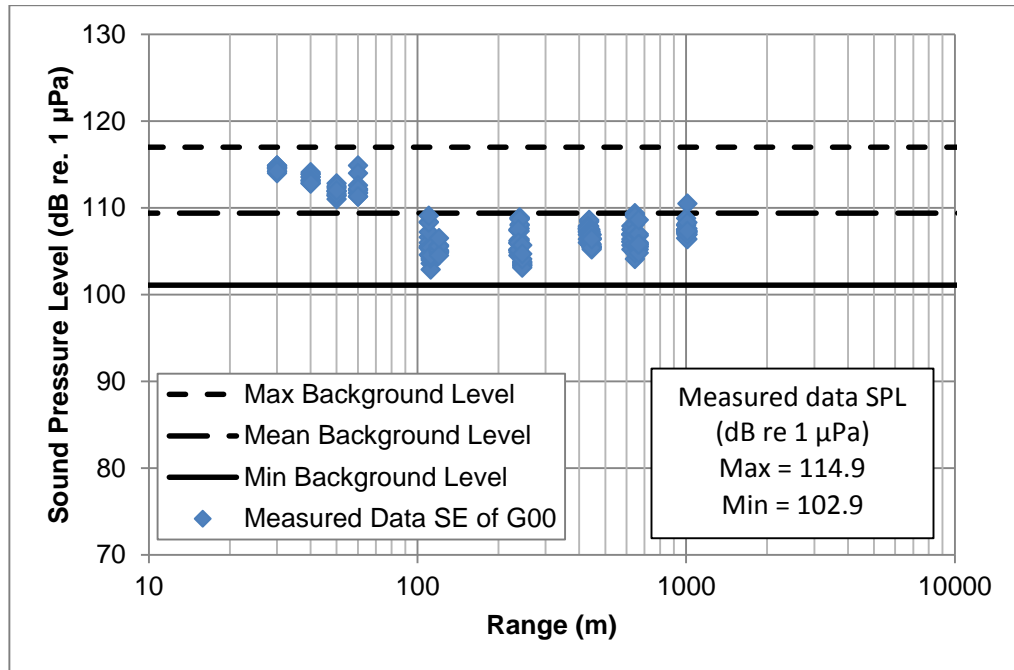
4.4.16. Figure 35 shows the measured data on the south east transect, where measurements were taken at a distance less than 100 m to the wind turbine. These are greater than the mean background level along the south east transects from G00. These data points exhibit an indication of reduction in level with range which may be due to the propagating operational turbine noise. However, at distances beyond 100 m the majority of measurements are seen to be below the mean background level and show no signs of any further reduction in level.

Figure 35 - Level versus range plot of data measured along the South East transect from G00 turbine on 30th July 2014 (Subacoustech, 2014)

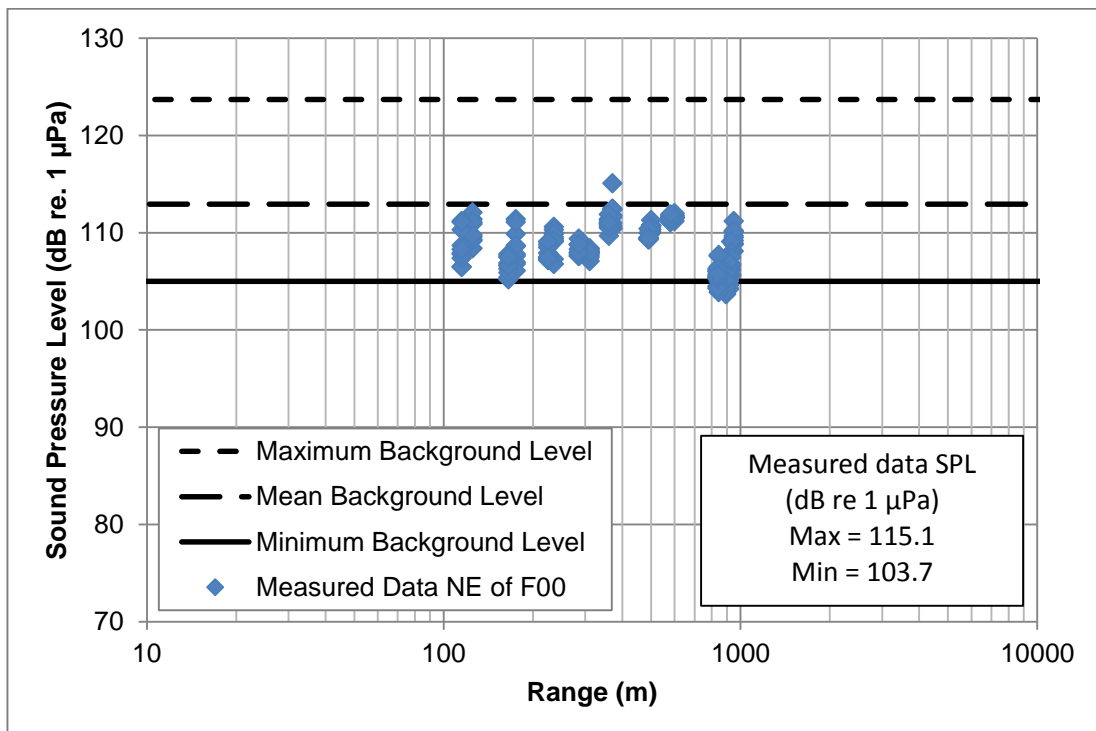
4.4.17. Similarly, Figure 36 illustrates that virtually all the measured data on the north east transect from F00, all taken at a range beyond 100 m from the turbine, were recorded to be below the mean background level. It was noted that the background measurements undertaken along the north east transect were dominated by vessel noise within Gunfleet Sands 1 and 2.

Figure 36 - Level versus range plot of data measured along the North East transect from F00 turbine on 30th July 2014 (Subacoustech, 2014)

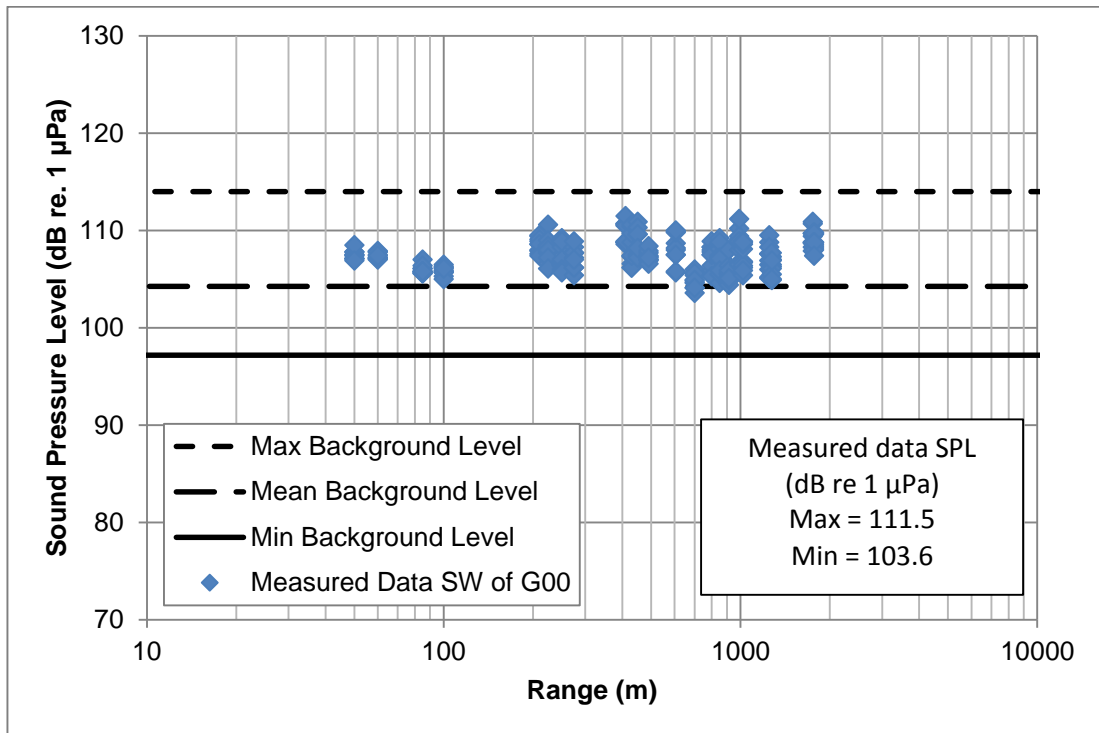
4.4.18. All the measured data along the south west transect from G00 presented in Figure 37 are seen to be equal or greater than the mean background level previously measured along that transect. The measurements at a range less than 100 m again exhibit a reduction in level with range. Conversely, the measurements taken at a distance greater the 100 m do not appear to fall below the previously measured mean background level and indeed some measurements are seen to be higher in level than the measurements close in to the turbine. This further supports the view that the noise being measured is unlikely to be attributable to the particular turbines at these distances.

Figure 37 - Level versus range plot of data measured along the South West transect from G00 turbine on 30th July 2014 (Subacoustech, 2014)
